## Eddy Current Inspection-based Damage Detection of Carbon Fiber Reinforced Polymer Composites

\*A.G.C.S. Amarasinghe, R.R.D. Ranawaka, E.H.N. Dilshan and H.M.C.M. Herath

Department of Engineering Technology, Faculty of Technological Studies, Uva Wellassa University of Sri Lanka

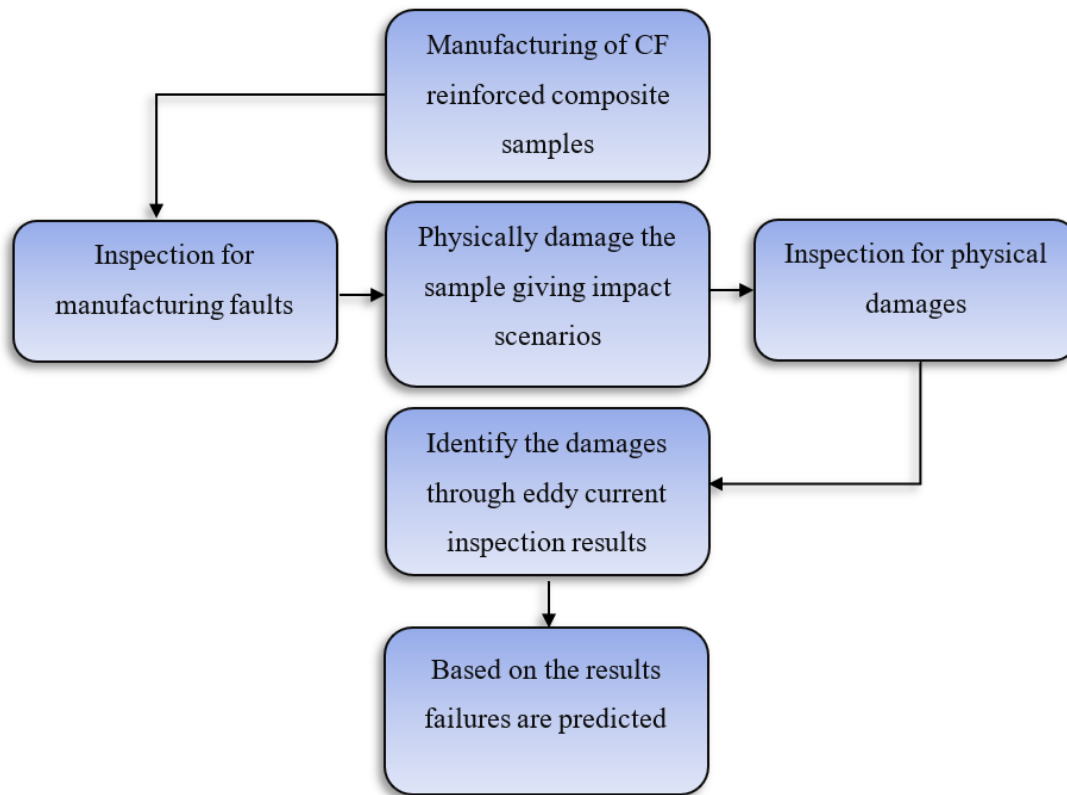
Fig. 1. The research methodology from manufacturing to investigating the defects on carbon fiber reinforced polymer composite samples

The research methodology followed during the research activity is shown in Fig. 1.

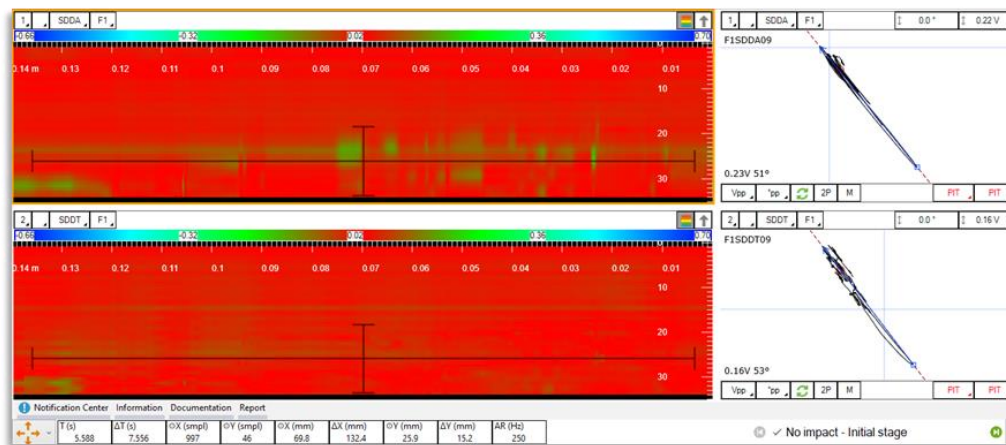
Fig. 4. C-Scan results of manufacturing defects

At the very beginning after making the sample, it was subjected for the experimental stage of manufacturing fault detection. As shown in Fig. 4. the manufacturing defects could be seen in green color with the red background area in C-Scan plane. The manufacturing failures clearly denoted not only in axial direction but also in transverse direction. At the initial stage the impedance plane angle was  $51^{\circ}$  in axial direction at the impedance voltage of 0.23V while  $53^{\circ}$  in transverse direction at the impedance voltage of 0.16V. With that angle, the crack propagation could be seen clearly in the impedance plane as well. These kinds of defects might occur due to delamination and matrix cracking effects. When the sample is manufactured, the CF fabric might have some voids in between CF woven strips or loosen braids in over under pattern of the woven. Since the CF material is a conductive material, conductivity barriers might occur for the eddy current loops generated while the scanning. Then the voids act as a barrier and considerable changes in the C-Scan plane show the shape of the defect as green areas. The impedance plane shows the behavior of crack propagation. Delamination effects may be occurred due to the loose compact of the layers, resin free areas, the mechanical status of the resin and hardener type, room temperature and cure temperature also might affect for the final quality of the CF sample and might occur conductivity barriers also. In here the sample has been made on a nonstick sticker without using air bags or

C- Scan and Impedance plane results in the initial stage before giving the impact damages as shown in Fig. 4.

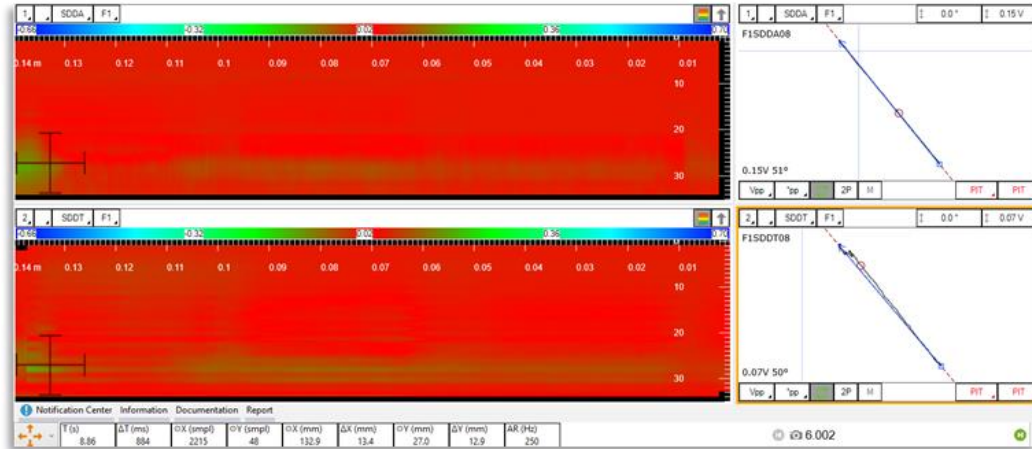
Fig. 6. Hammer impact damage results

The Fig. 6. indicates the hammer impact damage, visualizing and propagating on C-Scan plane. The impedance angle here is  $51^0$  as same as previous. In here the impedance voltage has been grown to 0.15V. With the high impact on the CF sample, the crack on 6.0Nm force has been grown with the hammer impact. On the transverse impedance plane, that change can be seen clearly. The delamination on 6.0Nm impact has been developed also. The CF strips were terribly damaged with the hammer impact. Discharge failure (failure of laminate) has been propagated gradually too.
